BUREAU OF SHIPS GROUP  
TECHNICAL INSPECTION REPORT

⑥ OPERATION CROSSROADS.  
U.S.S NEVADA (BB36).

TEST ABLE.

VOLUME I [redacted] [u] 8

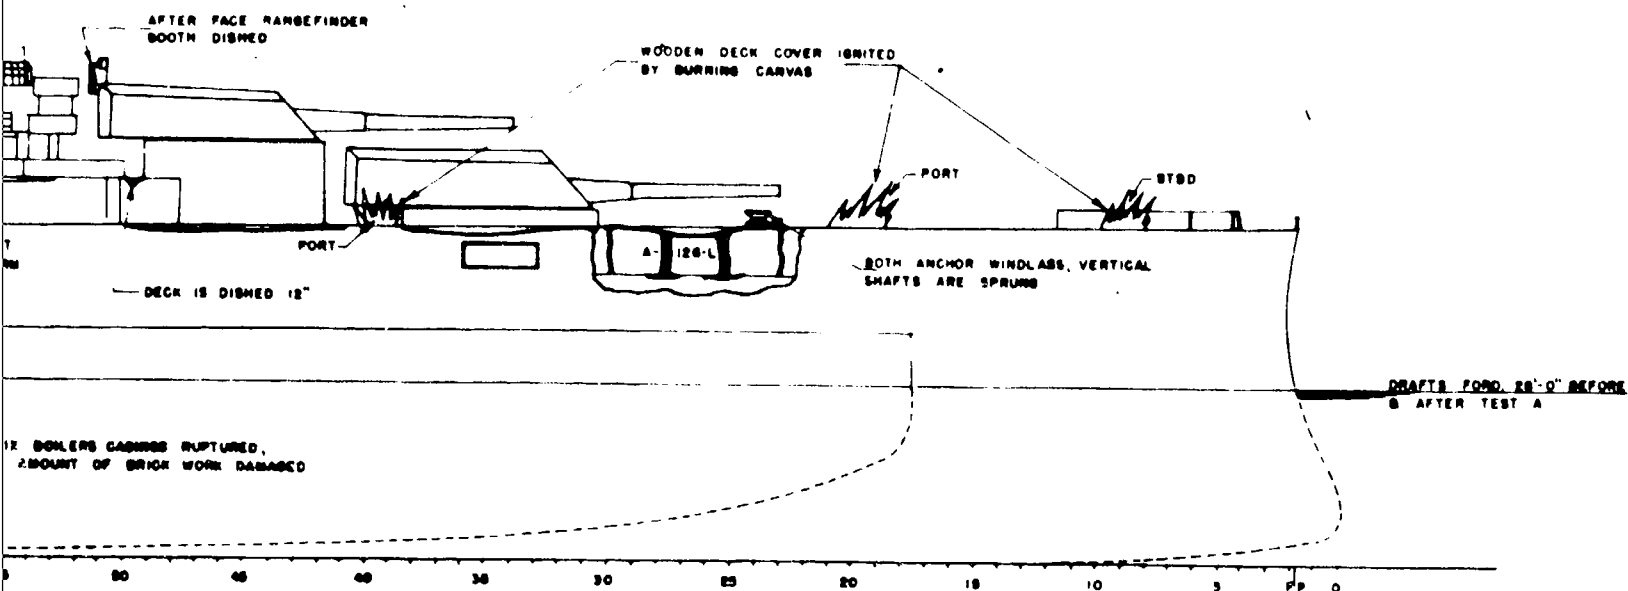
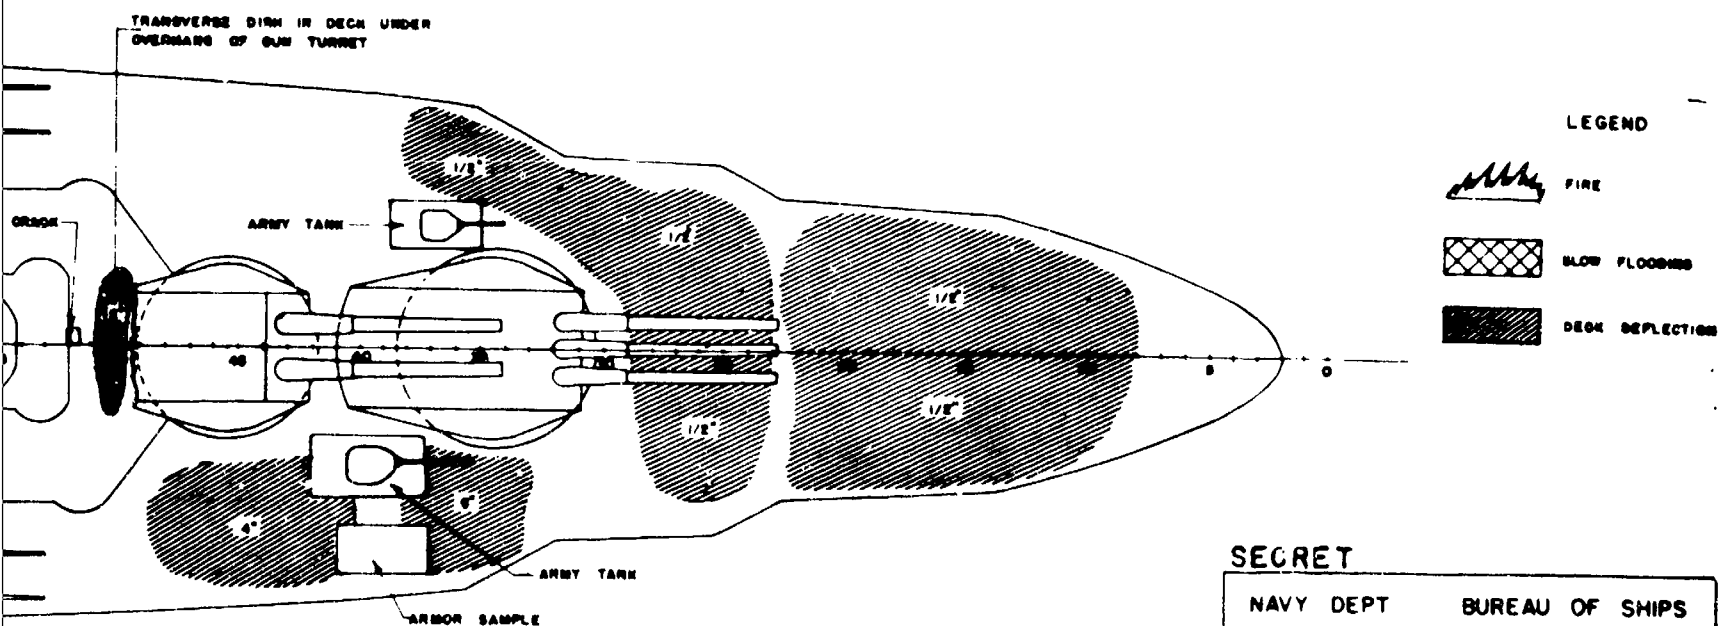
SHIP DAMAGE DIAGRAM

MISSING

5" SEARCHLIGHT DEMOLISHED

AT AFTER CORNER OF OPEN  
DECK PLATFORM BLOWN UP-  
RODS AT ABOUT A 30° ANGLE

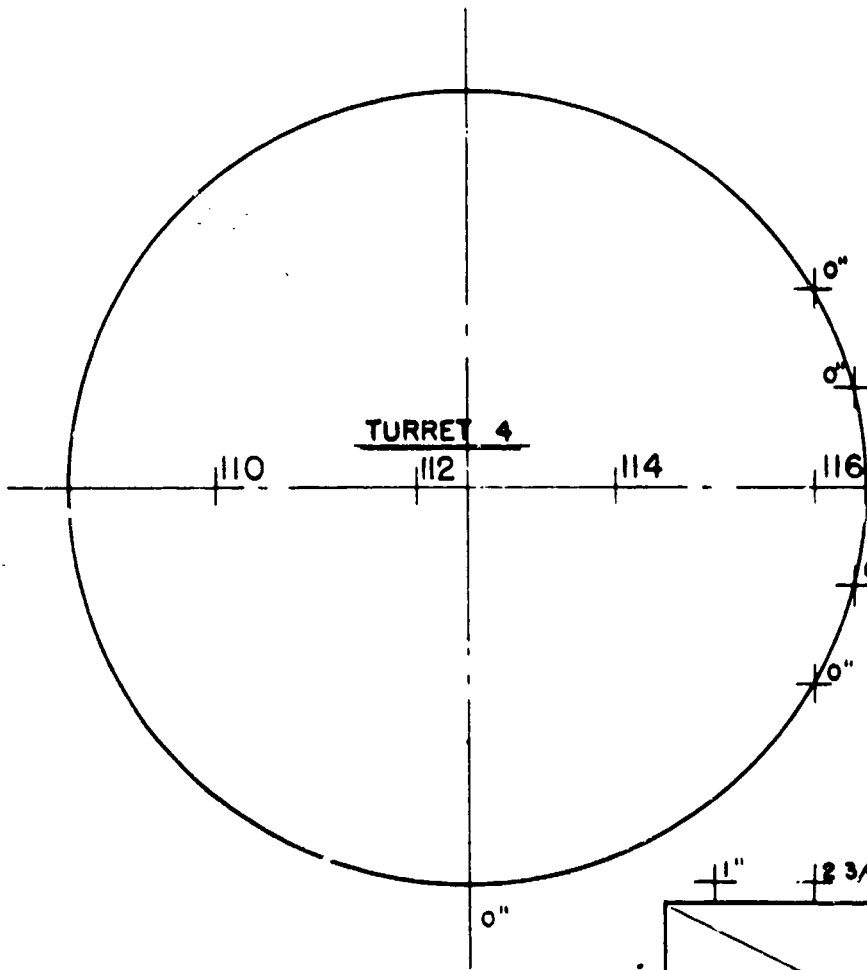
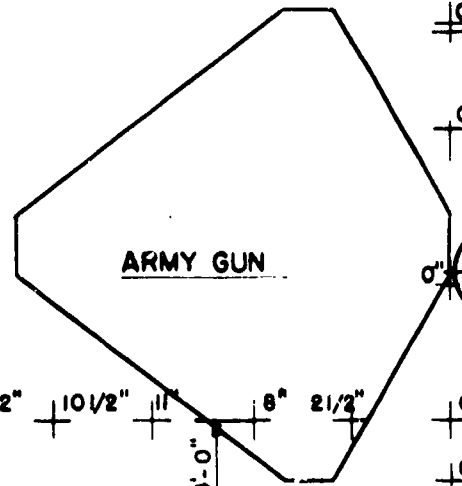
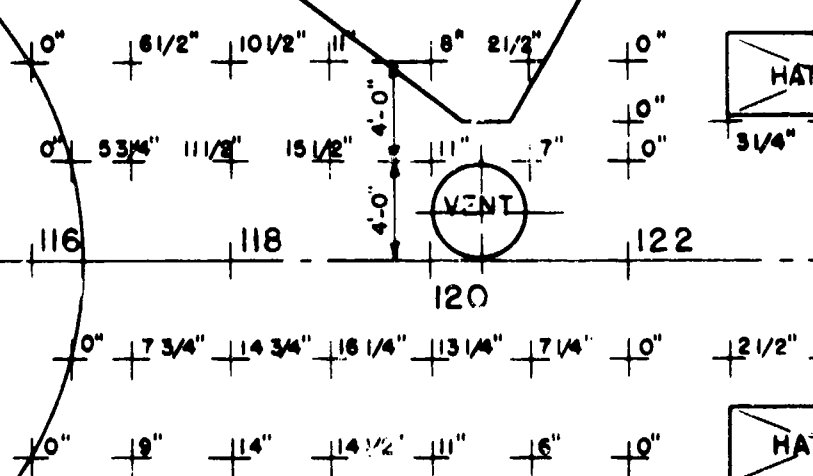
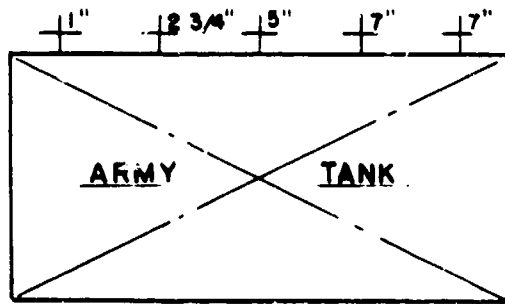
PLAN OF MAIN DECK  
FR. SPACING 4'-0"

(3) Special measurement of main deck failure.

Because of the marked failure of the main deck aft of turret 4, a special survey was conducted to determine the deflection pattern. The results of this survey are in figure 2, page 99 . Figures 3, 4, and 5, pages 100 , 101 , and 102 , show typical structure in this area.

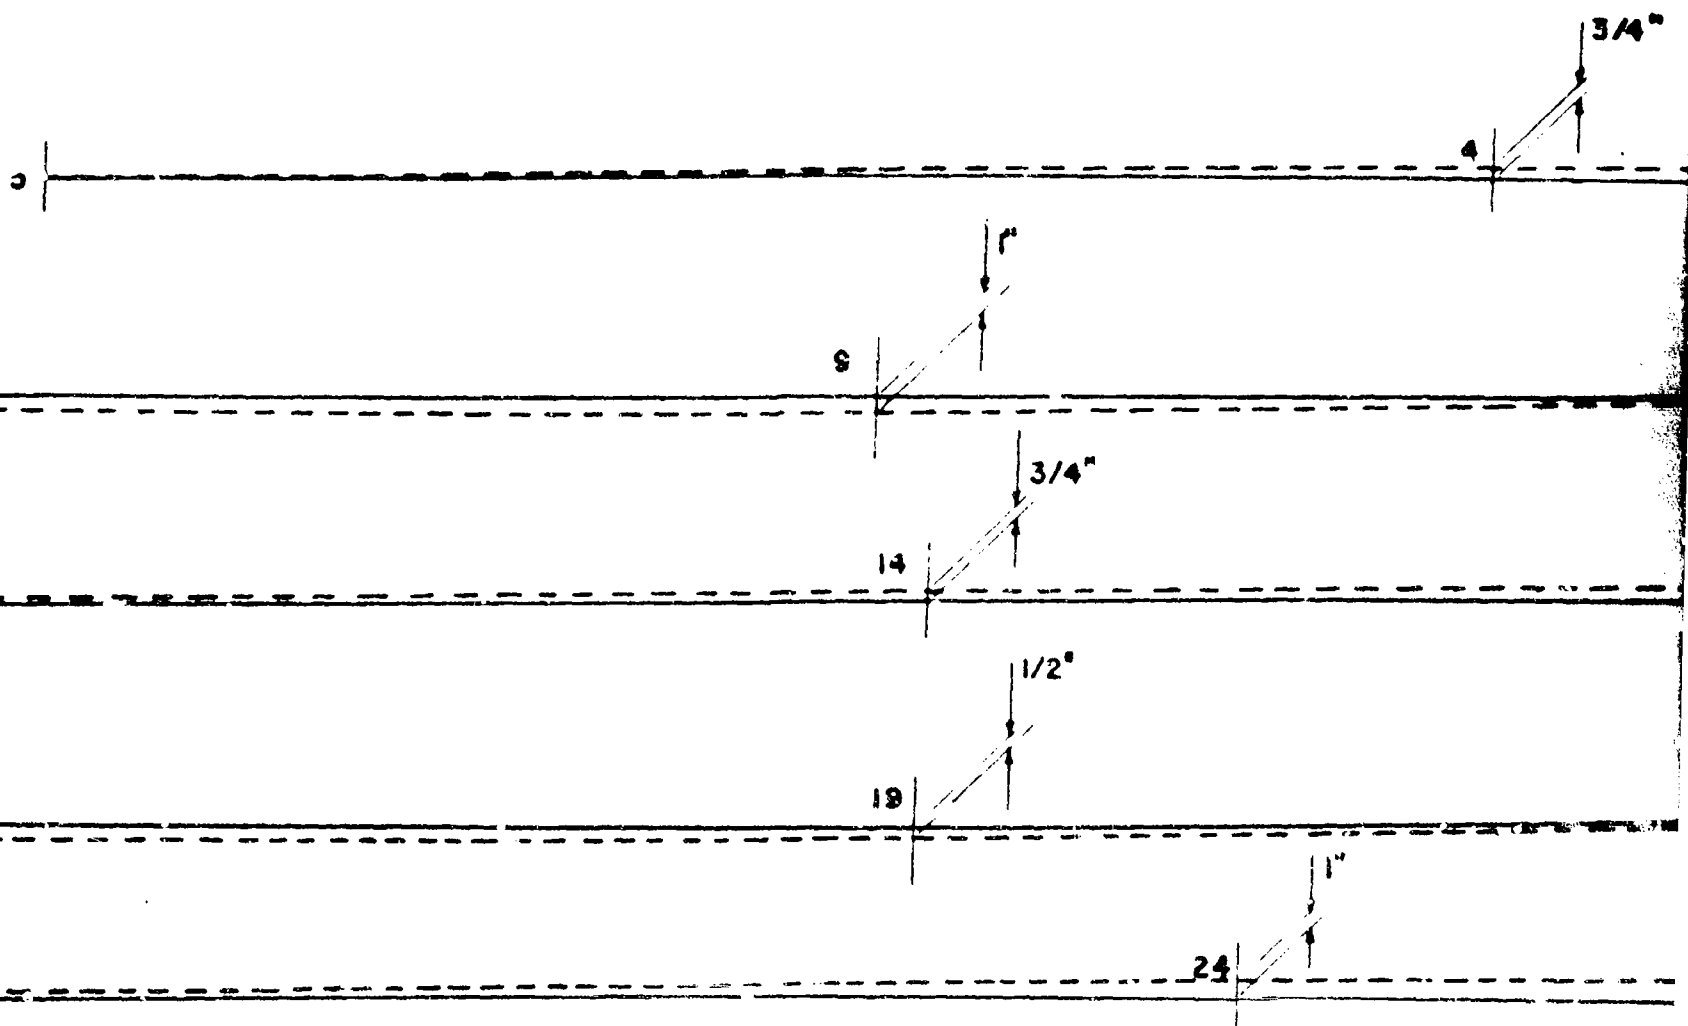
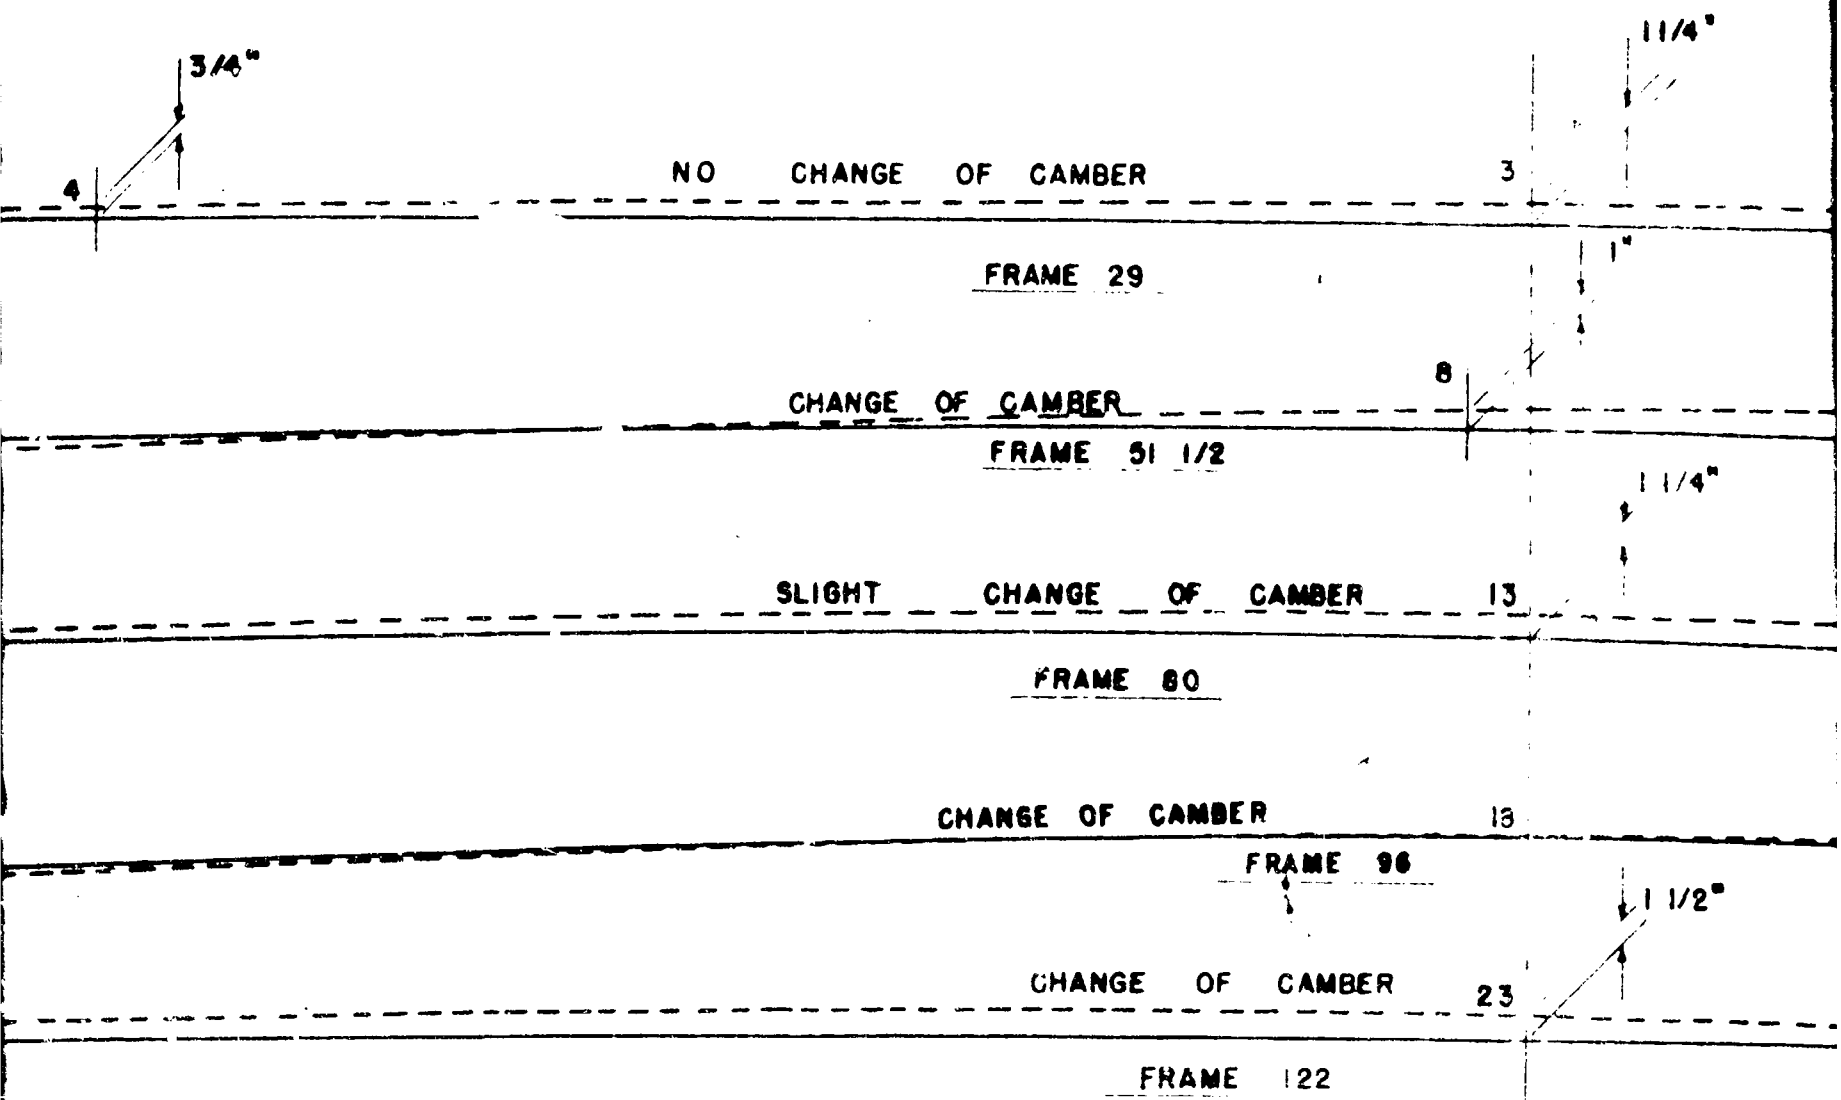
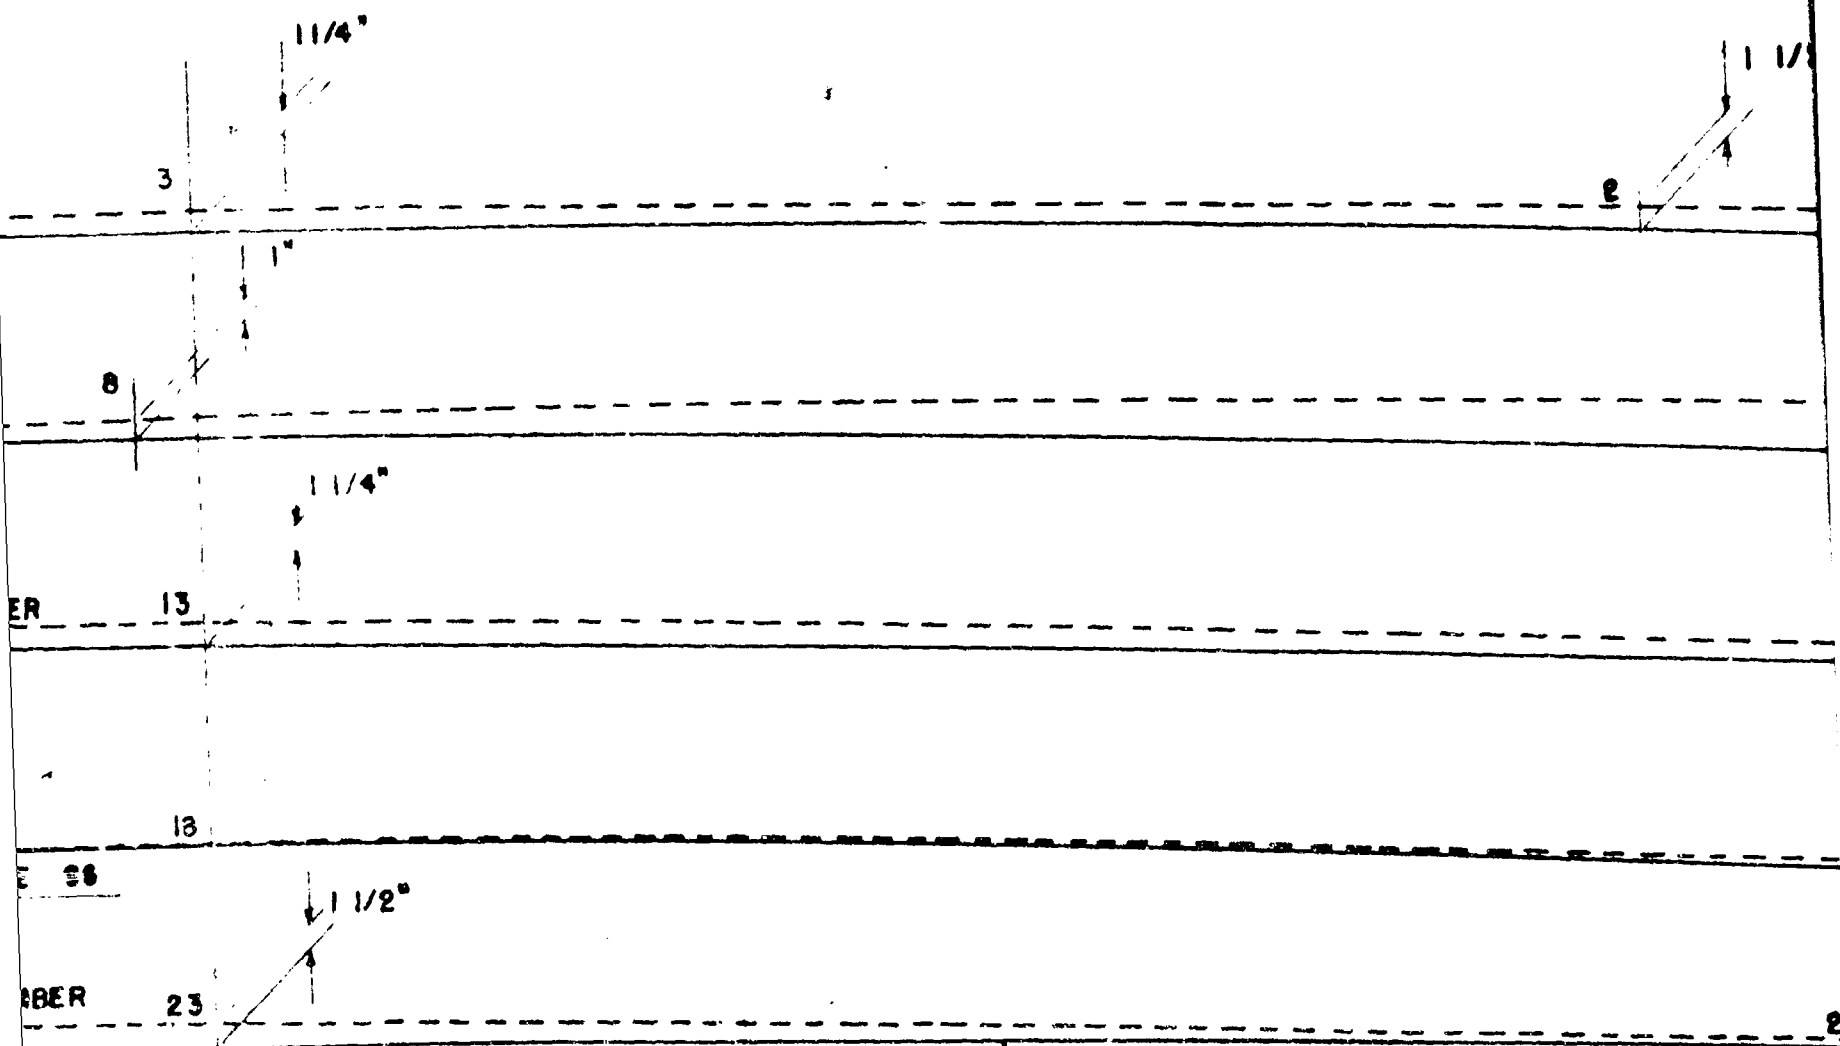
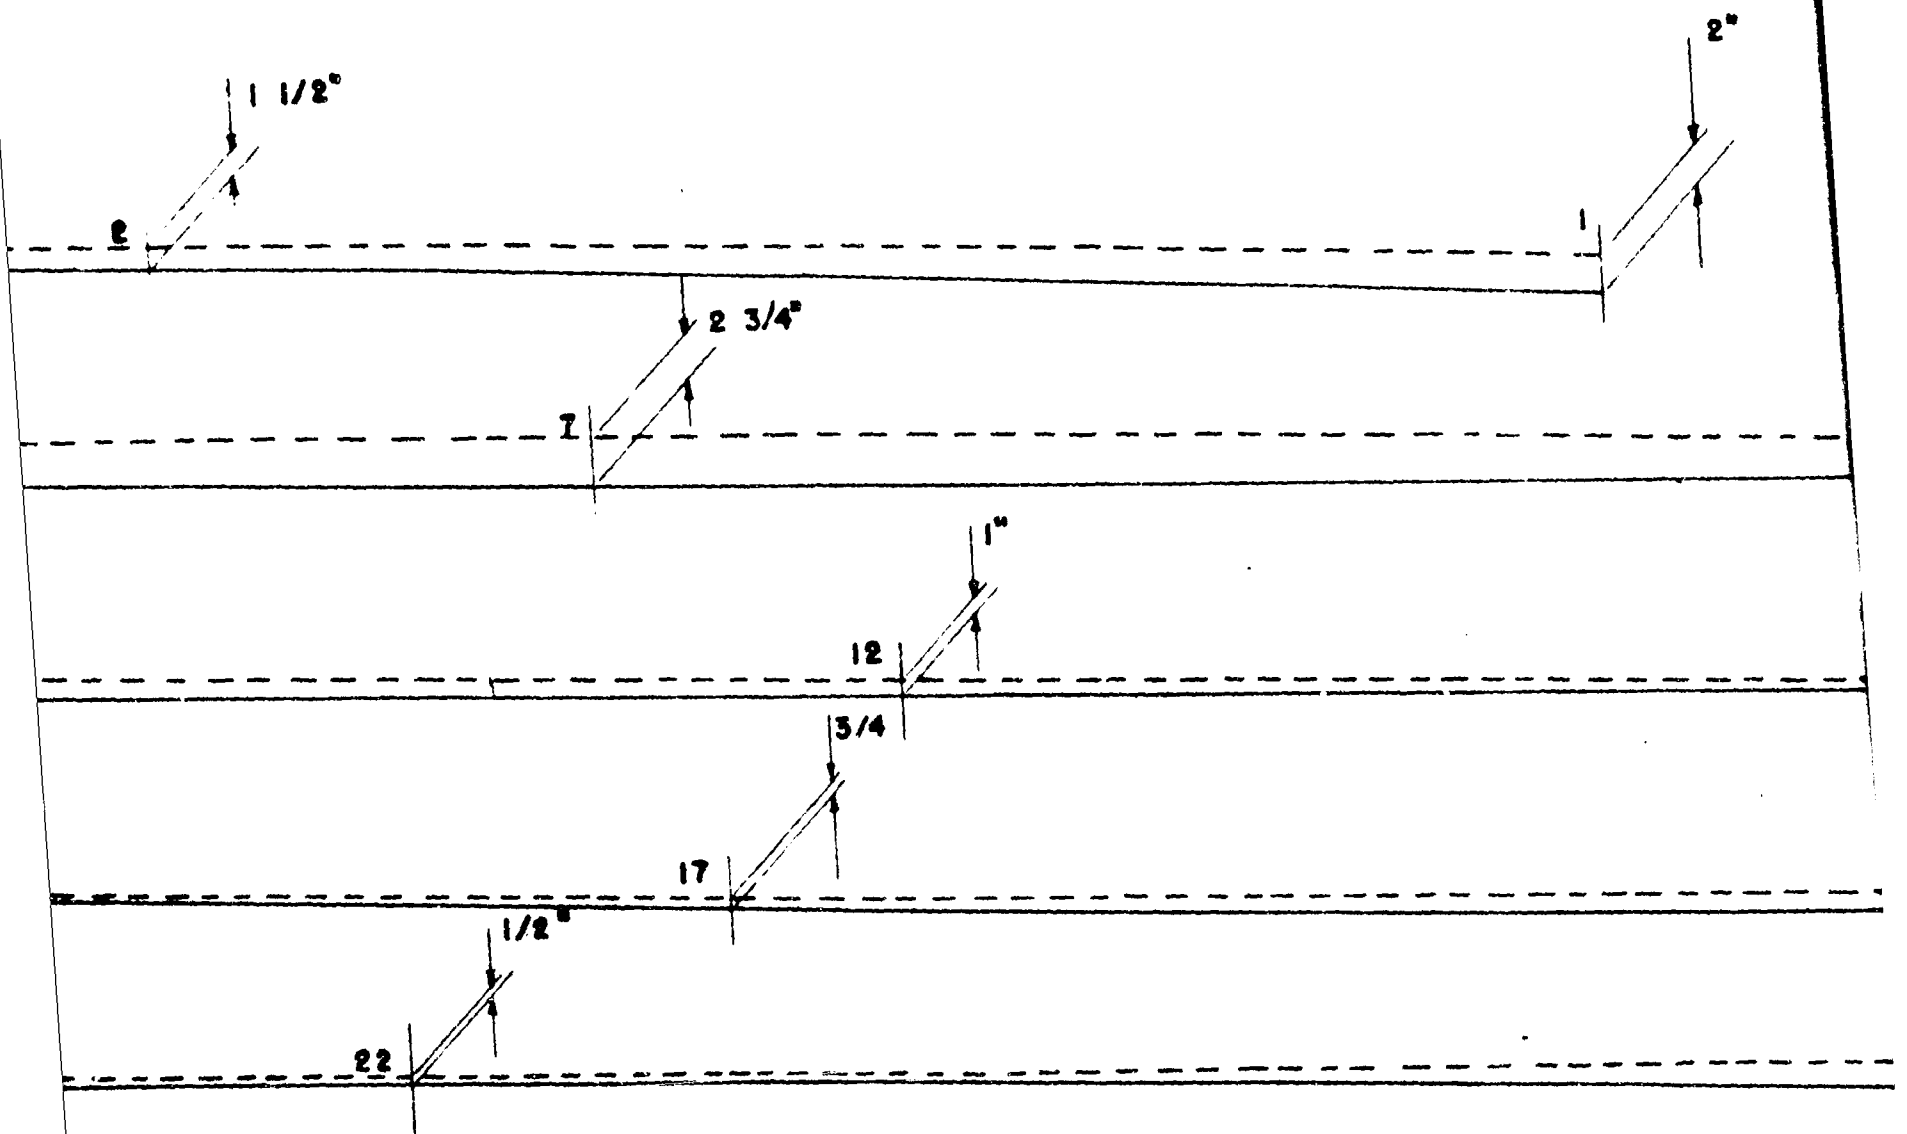
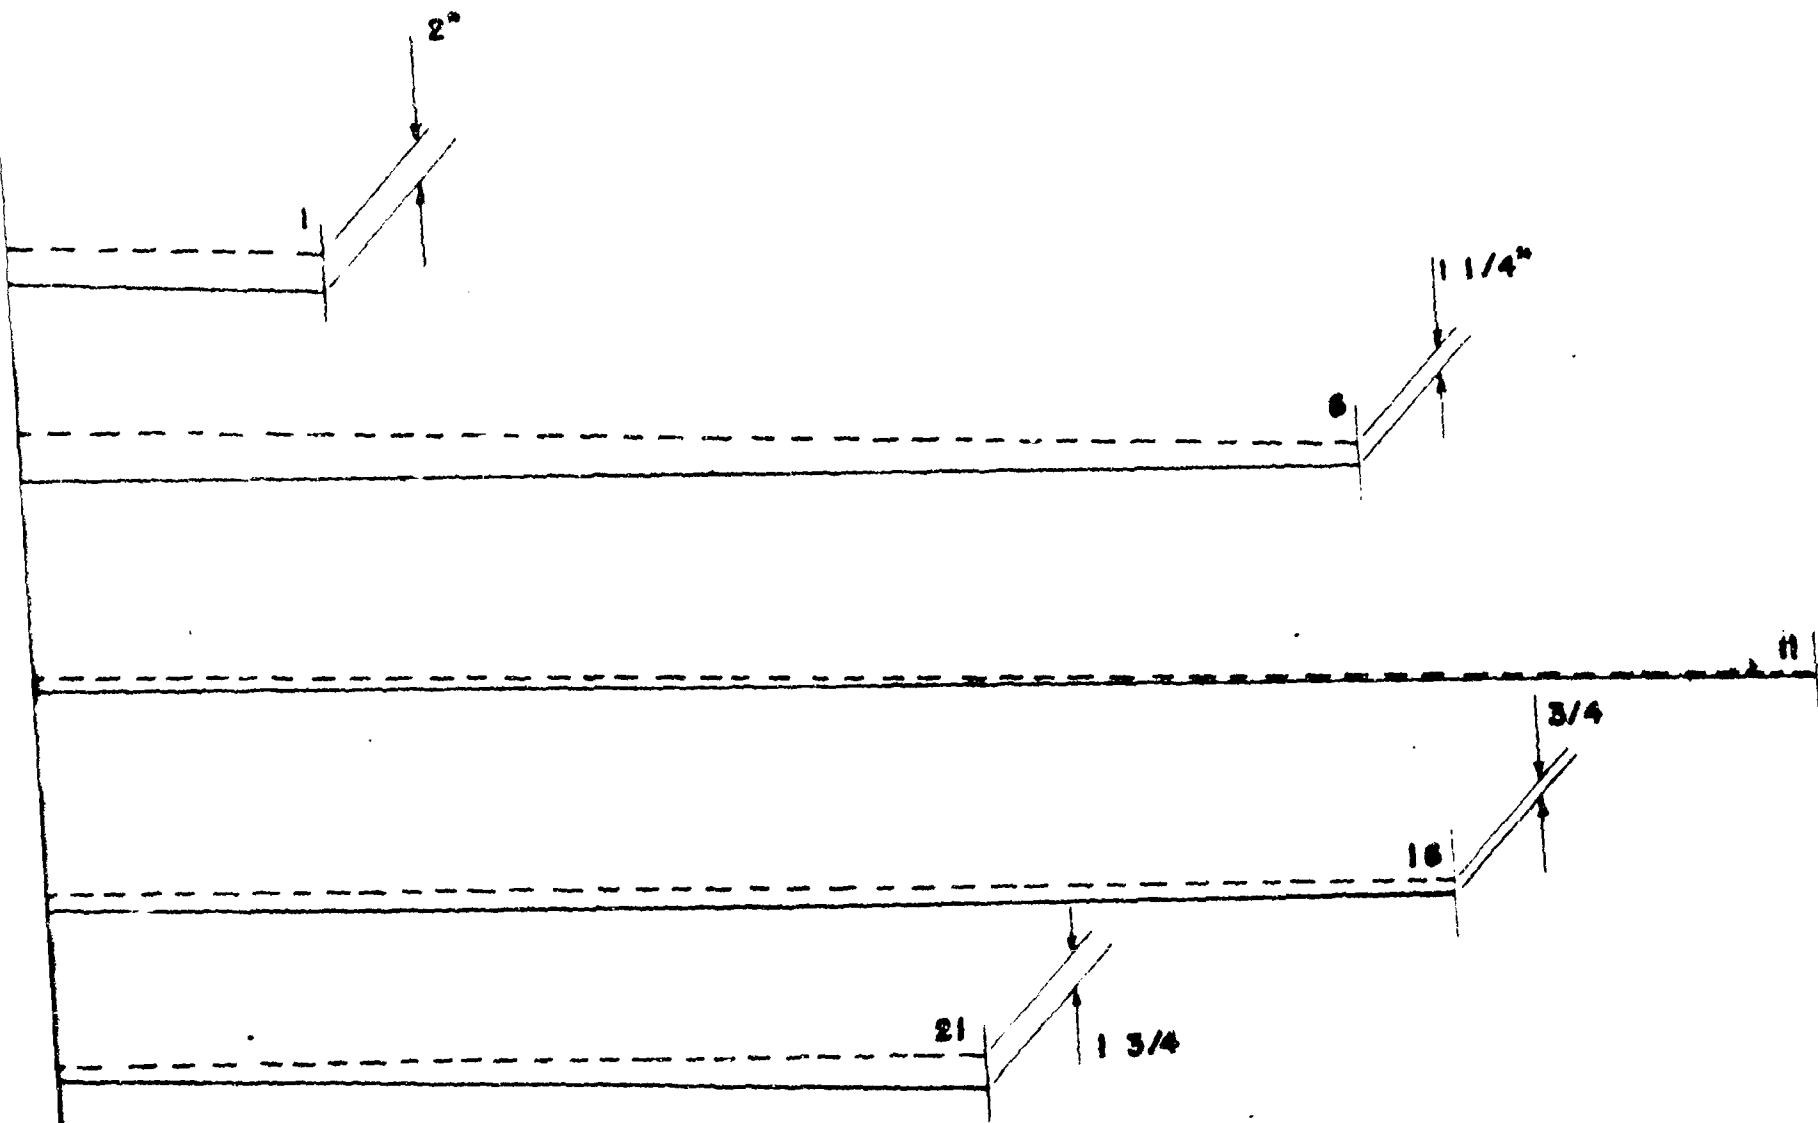
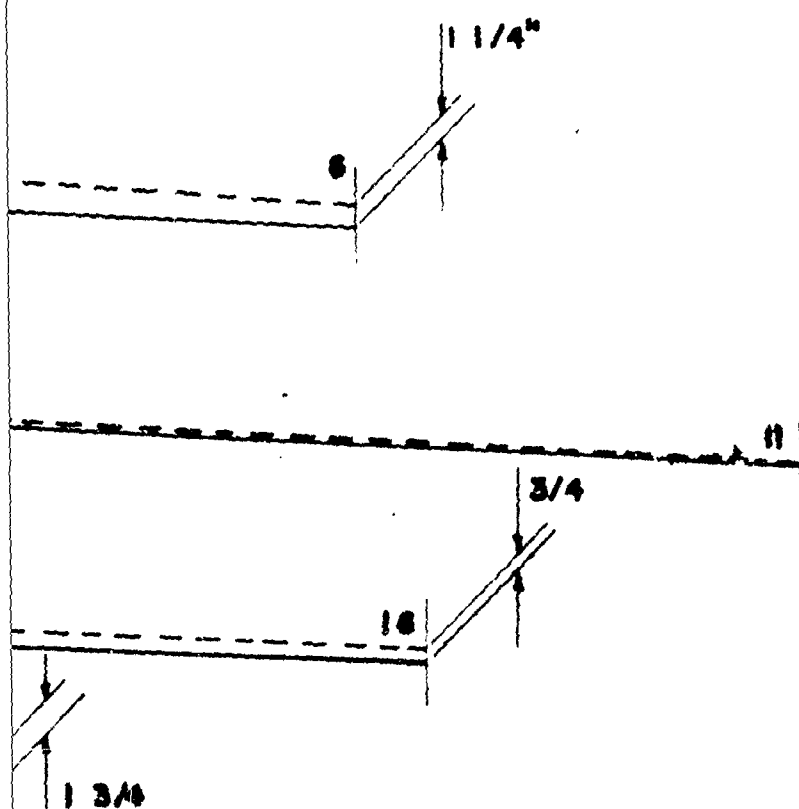
TRANSVERSE SECTIONS -- LOOKIN

The twist of the ships girder is of very low order and can be considered inconsequential. The plot of the transverse sections shown in figure 7, on page 104 reveals an untrue condition of twist. This condition is probably due to the varying loading conditions between the before and after survey and to local deflections caused by the twist.
